# Manhole Inspection Summary

Manhole # S11GG\_046MH

Insp Date: **1/13/09 2:47 PM**

**Location** Address: **3000 BAKER ST**

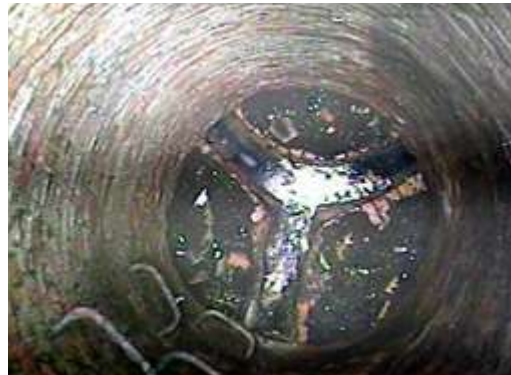
Top View

Count: **7** Missing: **0** ☒ **Corroded**

CORRODED STEPS

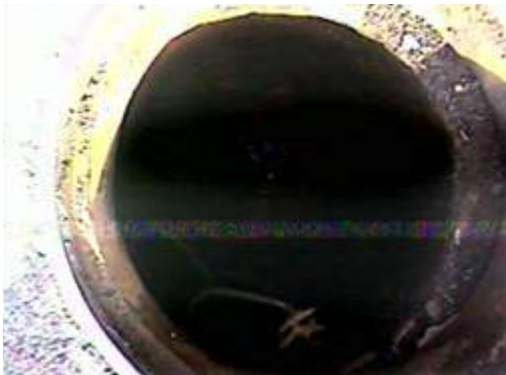
Defect 1

Offset: **3** (in.)

FRAME OFFSET

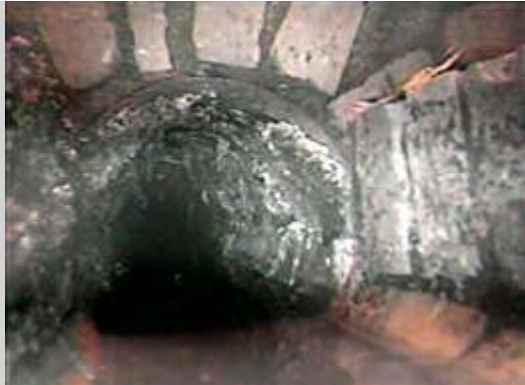
12 O'Clock Outflow

LOTS OF GREASE ON WALL OF PIPE

Pipe Height: (in.) Direct  
Pipe Material: **Clay** ☐ Pipe Lined  
Invert Depth: **11.86** (ft.) Flow Characteristics: **Slow**  
Deposits: ☐ None ☐ Mud ☐ Sludge ☐ Debris ☒ **Grease**  
Silt Depth: **1** (in.) Deposits Extent: **Medium**  
Infiltration: **None** Pipe Seal Cond: **Sound**

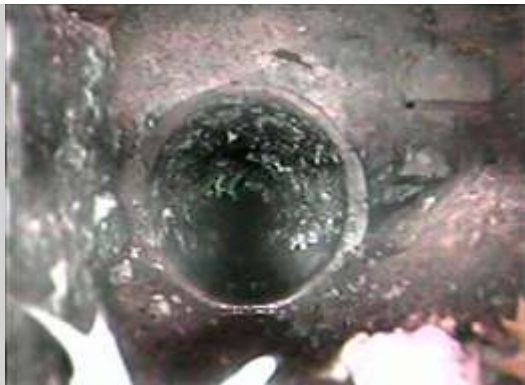
4 O'Clock Inflow

LOOKS LIKE MORE GREASE IN CHANNEL.

Pipe Height: (in.) Direct  
Pipe Material: **Clay** ☐ Pipe Lined  
Invert Depth: **11.85** (ft.) Flow Characteristics: **None**  
Deposits: ☐ None ☐ Mud ☐ Sludge ☐ Debris ☒ **Grease**  
Silt Depth: **0** (in.) Deposits Extent: **Medium**  
Infiltration: **None** Pipe Seal Cond: **Sound**

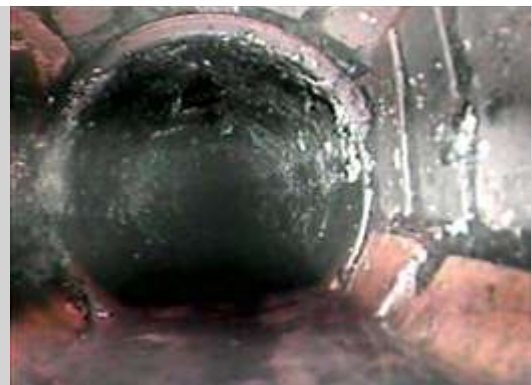
8 O'Clock Inflow

LOTS OF GREASE IN PIPE.

Deposits: ☐ None ☐ Mud ☐ Sludge ☐ Debris ☒ **Grease**

Silt Depth: **1** (in.) Deposits Extent: **Light**
